Wireless Strain Monitoring System on the Hernando de Soto Bridge During Critical Repairs

MEHDI KALANTARI KHANDANI
and MOHEB GHORBANISHEIKHNESHIN

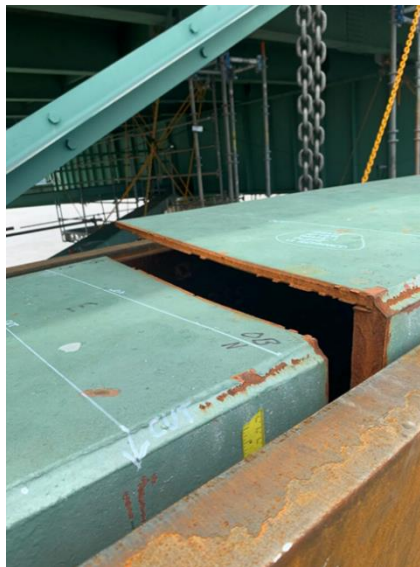
Figure 2. On May 11th, 2021, a crack was detected in main load bearings member of an I-40 bridge in Memphis, Tennessee and as a result, the bridge was closed immediately for the emergency repair.

During routine inspections conducted on May 11th, 2021, a partial fracture was discovered in a tie girder responsible for supporting one of the two tied-arch truss spans. The fracture was observed at a welded plate transition located in the upstream section of the box-shaped tension tie member (which functions as a tension strut to counteract the outward thrust forces exerted by the arches at the piers). In response to the crack, bridge inspectors promptly contacted emergency services through a 911 call, leading to an immediate closure of the six-lane bridge. The bridge remained non-operational to traffic until emergency repairs were completed in August 2021 [3] [4].

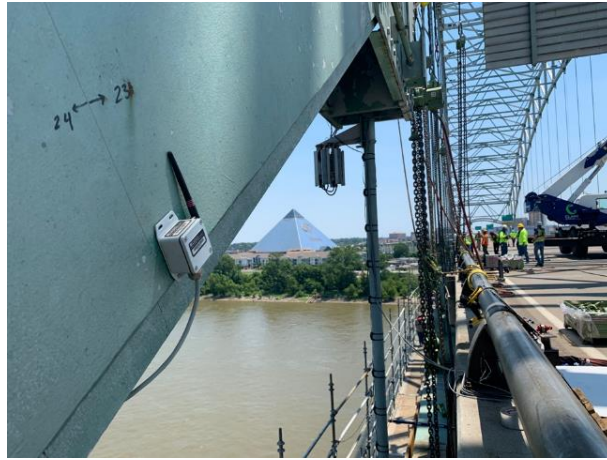
Figure 3. Examples of installed wireless strain gauge SenSpot™ sensors on I-40 bridge (the wireless unit with the antenna on the left side of the picture)

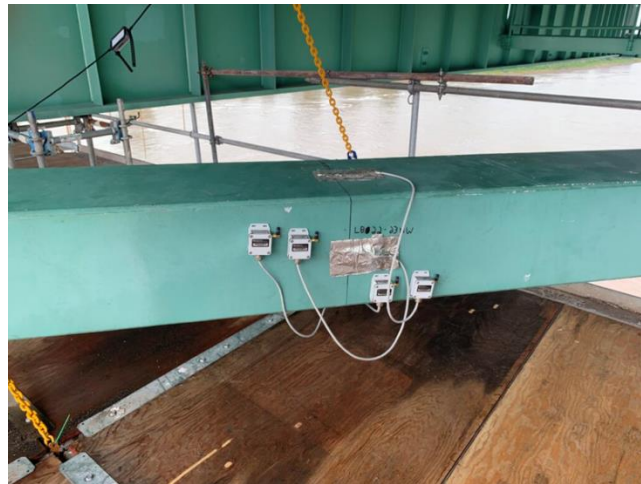
Figure 4. Installed wireless strain gauges SenSpot™ sensors on I-40 bridge

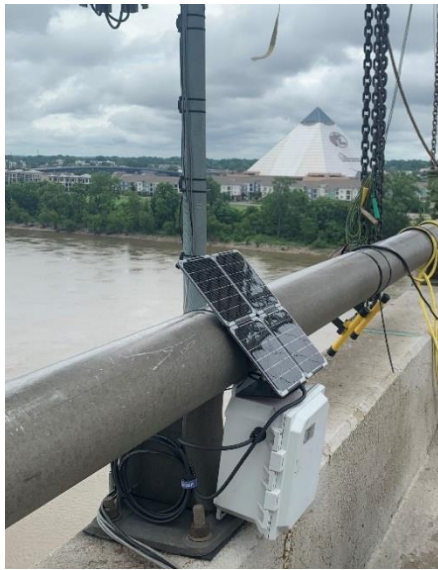
Figure 5. Installed solar powered SeniMax™ gateway on I-40 bridge for data acquisition

SeniMax™ [2] remote communication gateways are solar powered. As a result, the complete system is energy self-sufficient and does not require access to external electrical input or infrastructure for its operation.
