Enhanced Numerical Simulation and Experimental Validation of Dam Gate Trunnion Rod Anchorage Systems Under Varied Pre-Tensioning Conditions

ABSTRACT

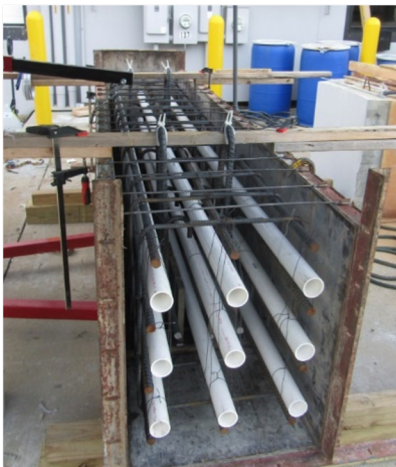
Figure 1: Trunnion beam's rebars and ducts prior to concrete pouring.

Before testing commences, the rods are individually post-tensioned and balanced before load application through the actuators. Identical actuators are positioned on opposite sides of the reinforced concrete beam to apply equal loads to the rods via a built-up girder situated over the ends of all rods. This loading simulates the hydrostatic pressure exerted against the Tainter gate. **Error! Reference source not found.** illustrates the trunnion beam's rebar and ducts before the concrete pouring process. Figure 2 depicts the test configuration of the trunnion beam.

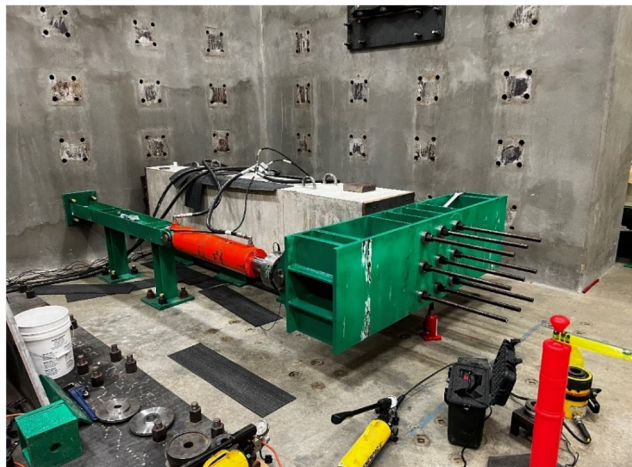
Figure 2: Trunnion beam's test configuration.

The reinforced concrete beam features nine trunnion rods arranged in a three-by-three grid. This beam is designed to simulate the concrete pier of a dam and is anchored to the strong floor with threaded rods to ensure stability. The test configuration was tailored to fit the laboratory space, utilizing the strong floor for anchoring the reinforced concrete beam and an adjacent strong wall to secure two identical actuators that would apply the load. Each trunnion rod is outfitted with a load cell fixed at its dead end to monitor tension throughout the testing process.

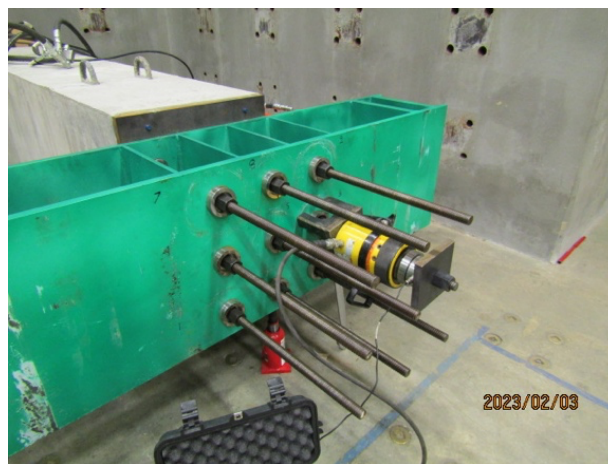
Figure 3: Trunnion rods' post-tensioning and load balancing prior to testing.

Before each test, all nine trunnion rods were individually tensioned to a specified percentage of the Guaranteed Ultimate Tensile Strength (GUTS) value, as illustrated in Figure 3. Care was taken to monitor the load cells attached to the dead ends of the rods to ensure that the tensions were balanced as closely as possible, aiming for a tolerance of approximately 0.5 kips. Figure 3 shows the trunnion rods' post-tensioning and load balancing prior to testing. Once all nine rods were balanced, the specified rod or rods were completely detensioned. This adjustment slightly alters the load distribution in the remaining rods before additional loads are applied.
